DRONE INSPECTION REPORT

# Sample Project

Commercial roof · Aerial photo map + thermal inspection

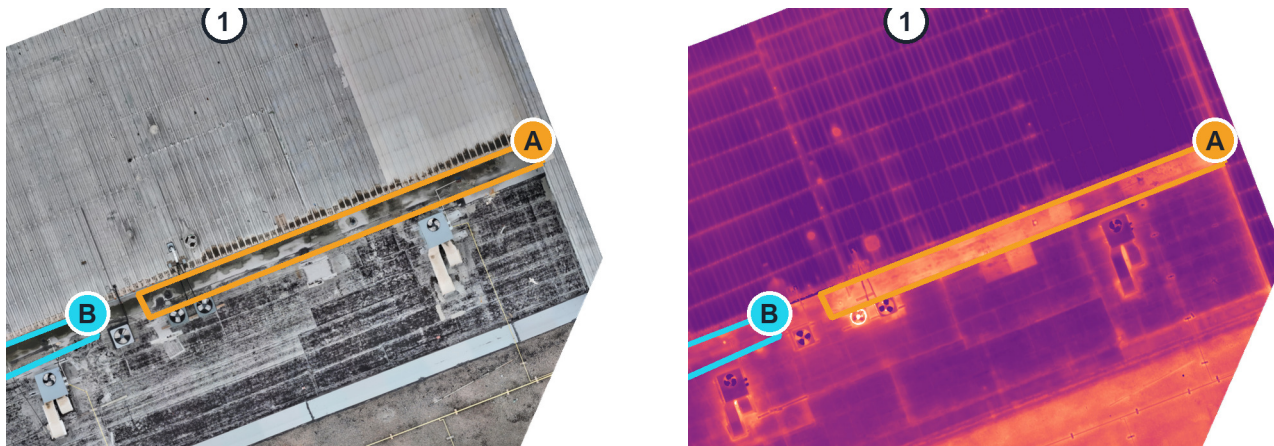
### A. Outline

Primary (metal-roof runoff onto TPO)

Thermal captured approximately 9:30–10 PM after daytime solar loading. Linear thermal anomaly on the TPO directly beneath the drip edge of the sloped standing-seam metal roof, adjacent to rooftop equipment. RGB (daytime flight) shows staining on the lower metal ribs and at the tie-in, consistent with runoff from the metal roof concentrating along this strip. The warm pattern is consistent with retained heat from repeated wetting along this strip and/or in the first panels of the receiving roof.

Control: the TPO west of this strip is significantly darker in RGB (daytime flight) and remains thermally cool, so stain density and membrane color do not explain the warm run.

Recommend moisture-meter verification along the warm segment and immediately off equipment curbs. Recommend a qualified roofer and/or plumber inspect this drainage path for proper function (open flow, debris, standing water, overflow onto the TPO). This is not a determination that the drainage has failed and is not a repair recommendation.

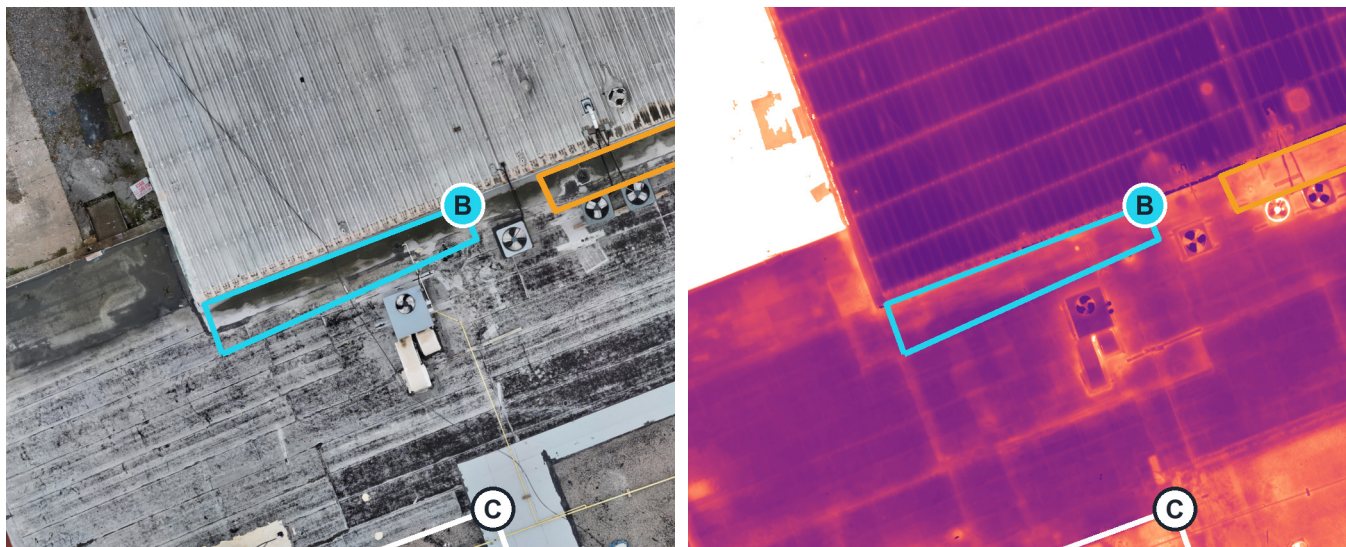
## B. Outline

Paneled TPO is mottled and stained in RGB (daytime flight). Most thermal variation on this field tracks surface soiling and panel layout, not a discrete moisture bloom. Darker TPO in this area remained cool on the evening flight. Treat as general covering condition unless a meter identifies specific outlier panels.

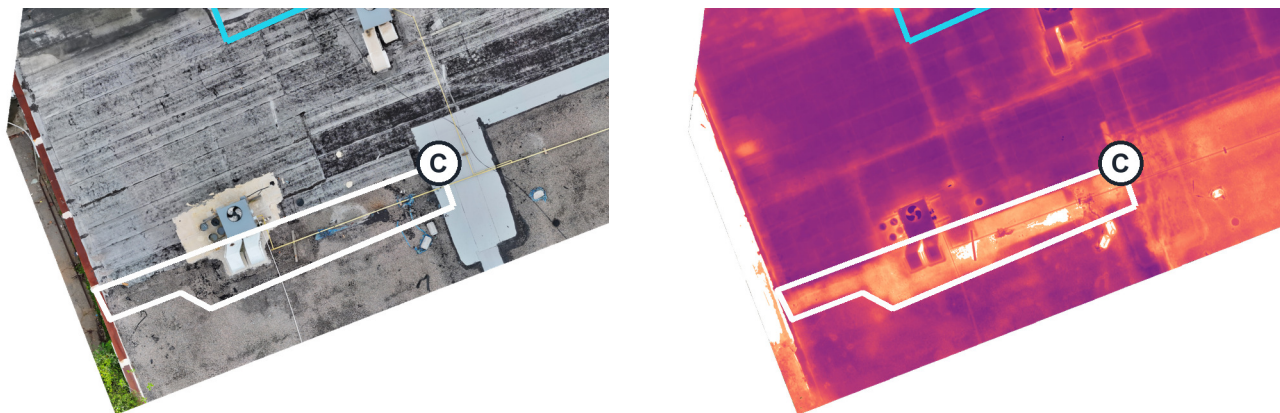
## C. Outline

Thermal variation at the ballasted corner adjacent to the large RTU. RGB (daytime flight) shows mixed/darker aggregate and debris in the same footprint. Pattern is consistent with ballast color and texture.

Not a standalone moisture call from imagery. Meter only if interior evidence exists.

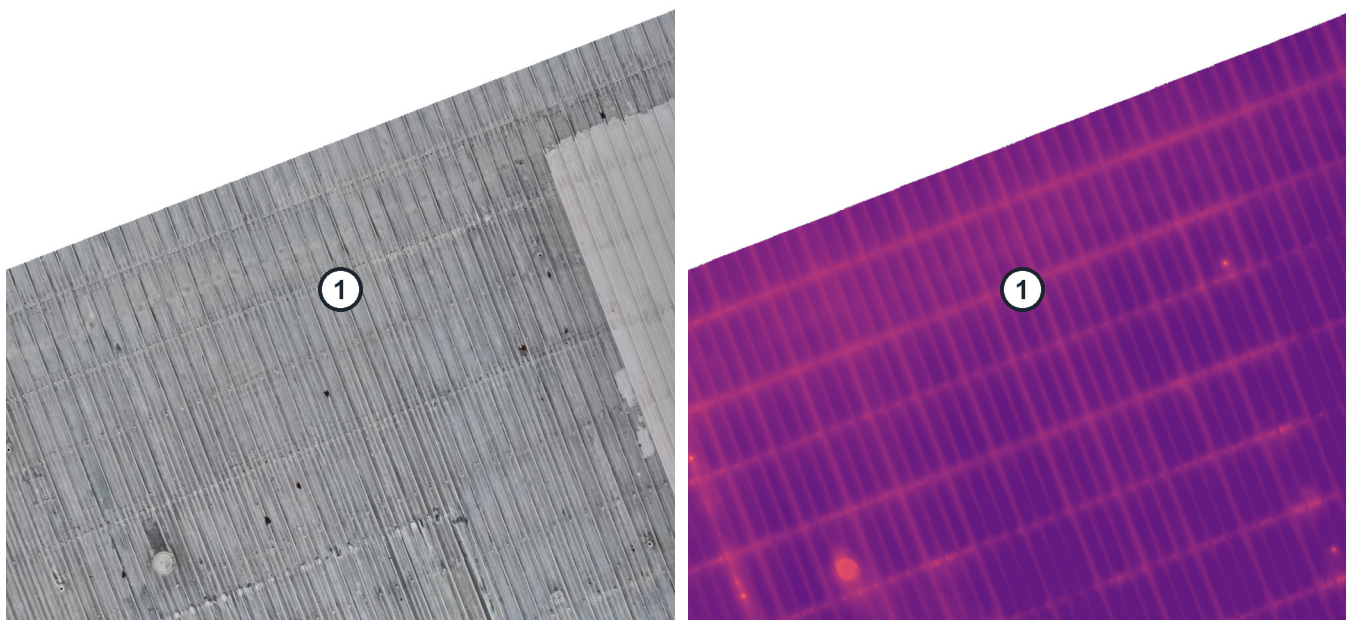
## 1. Marked point

Sloped standing-seam metal

Large sloped metal plane is thermally uniform aside from the discharge edge in outline A. Rib pattern is regular. No widespread anomaly identified on this field from the evening dataset.

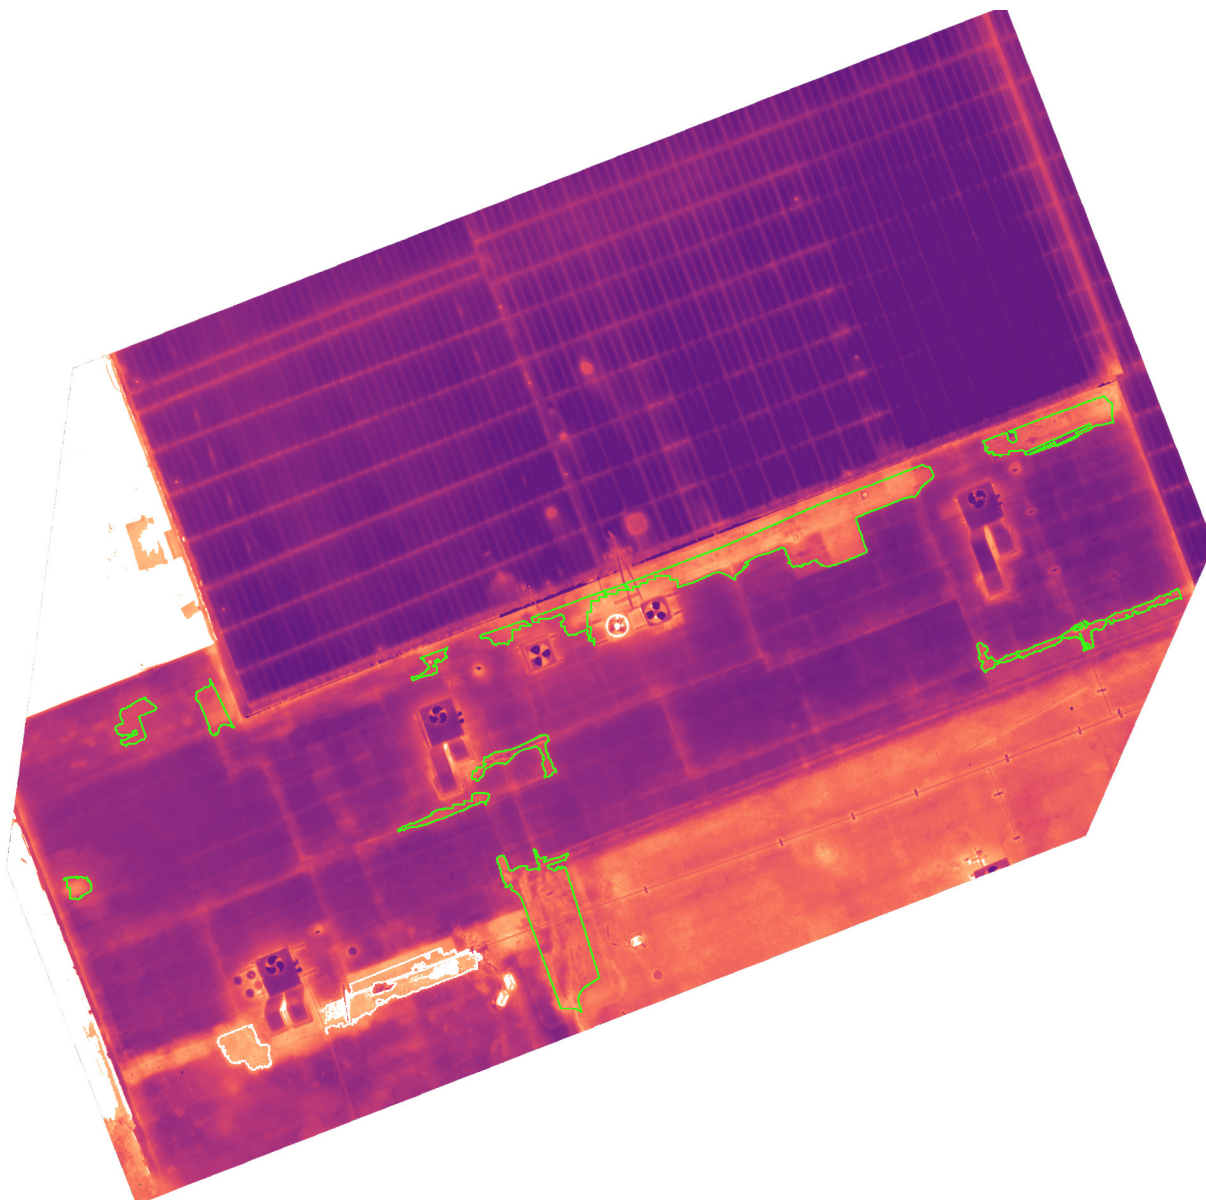
## Screening map

Screening marks (12, outlined in green): spots warmer than the rest of their roof section, the suspect areas counted in the table above; 3 observed patterns on stone ballast (white dashed): not moisture readings and not counted; 8 of the 23 lie outside the cropped sample area and are not shown. The thermographer reviewed each one; the findings are the ones described in the report body.
