DRONE INSPECTION REPORT

# Sample Project

Commercial roof · Aerial photo map + thermal inspection

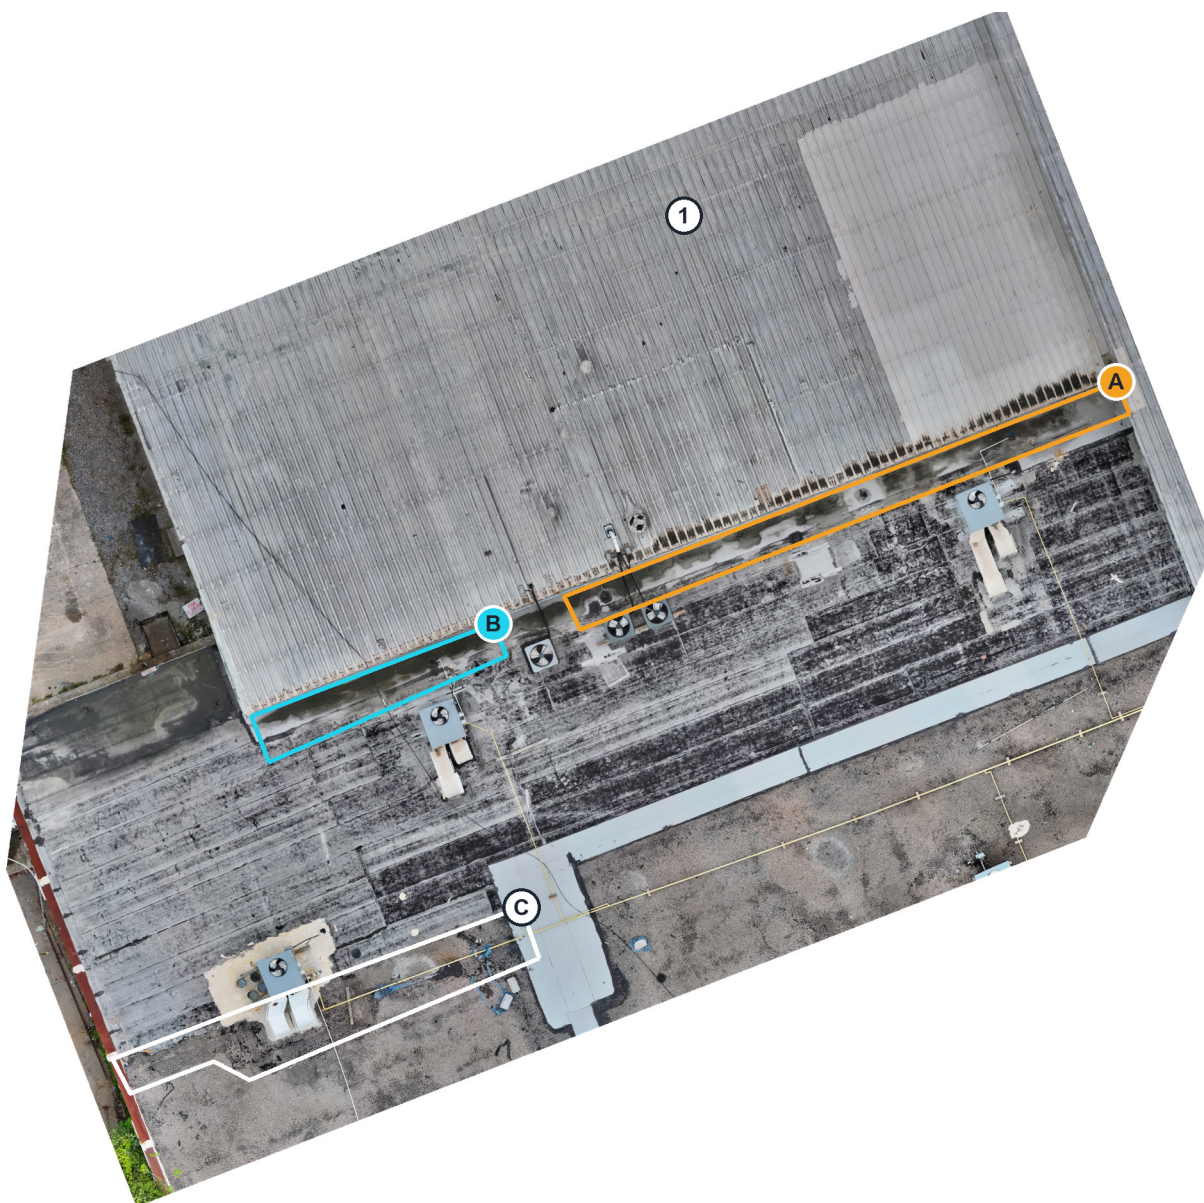
**One area needs follow-up: the warm line where the sloped metal roof drains into the collector (outline A), recommended for moisture-meter verification. The other marked areas are consistent with surface conditions rather than a discrete moisture signature.**

Daytime aerial photo map with annotations: numbered points and lettered areas, outlined in the thermographer's colors (they match the online map); see Annotations. Orientation altered for privacy; no north arrow.

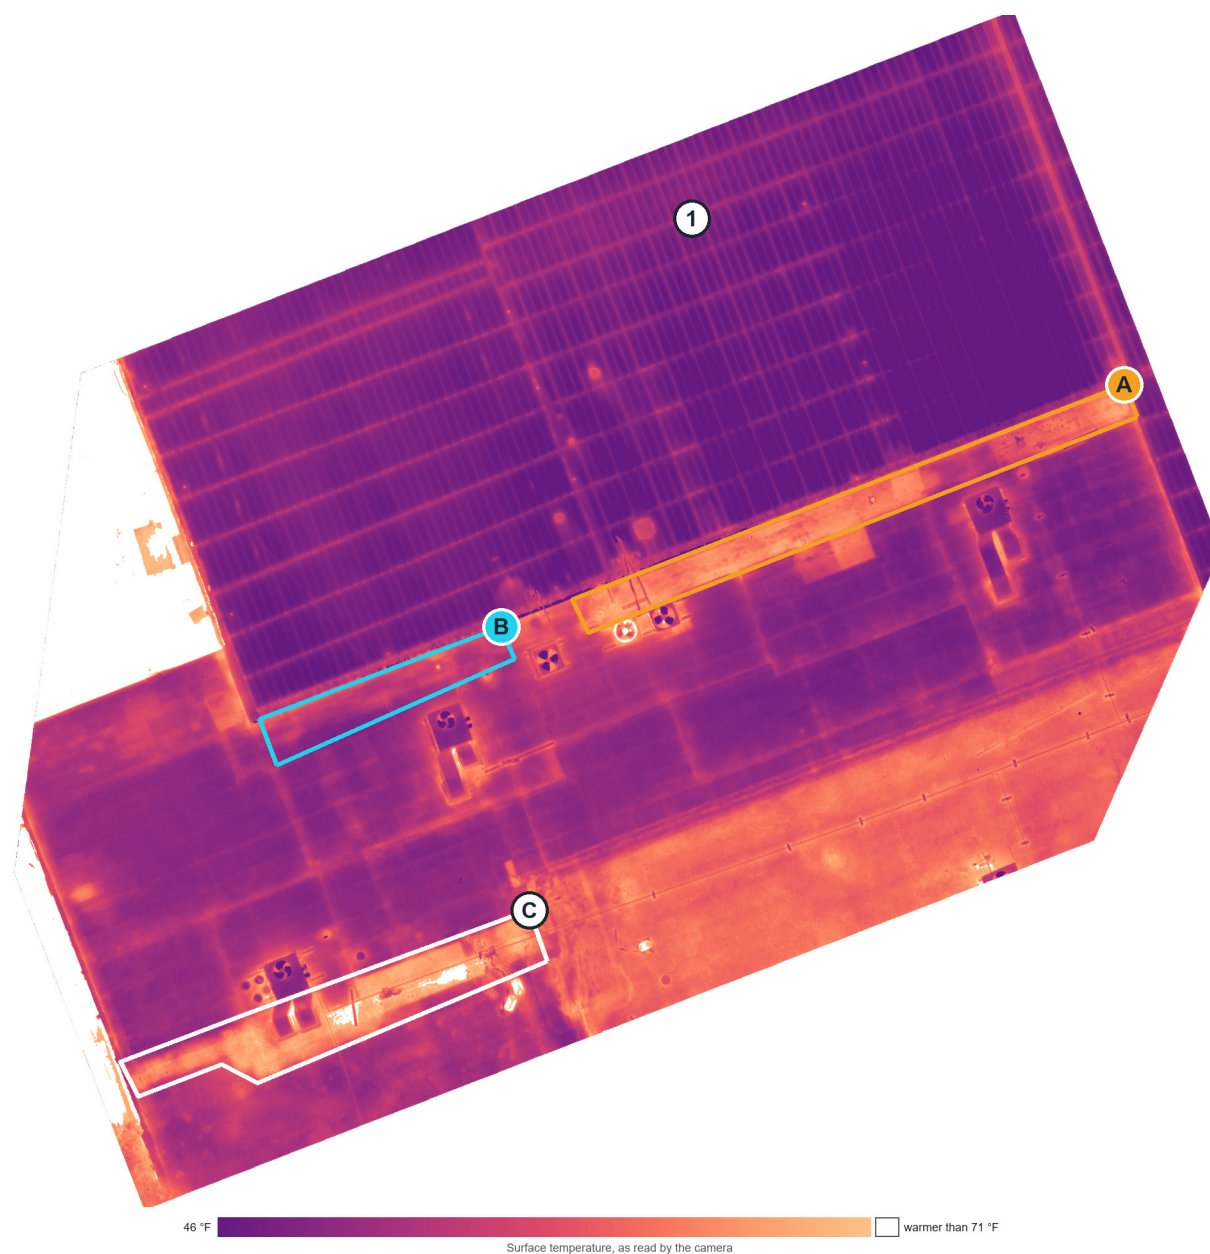
*Thermal overlay with annotations: numbered points and lettered areas, outlined in the thermographer's colors (they match the online map); see Annotations. Orientation altered for privacy; no north arrow. Color scale: 45.7 °F (7.6 °C) dark purple to 70.7 °F (21.5 °C) pale orange; areas warmer than 70.7 °F (mostly pavement and ground, which hold more heat than the roof) are shown white.*

Thermal captured approximately 9:30–10 PM after daytime solar loading. Linear thermal anomaly on the TPO directly beneath the drip edge of the sloped standing-seam metal roof, adjacent to rooftop equipment. RGB (daytime flight) shows staining on the lower metal ribs and at the tie-in, consistent with runoff from the metal roof concentrating along this strip. The warm pattern is consistent with retained heat from repeated wetting along this strip and/or in the first panels of the receiving roof.

Control: the TPO west of this strip is significantly darker in RGB (daytime flight) and remains thermally cool, so stain density and membrane color do not explain the warm run.

Paneled TPO is mottled and stained in RGB (daytime flight). Most thermal variation on this field tracks surface soiling and panel layout, not a discrete moisture bloom. Darker TPO in this area remained cool on the evening flight. Treat as general covering condition unless a meter identifies specific outlier panels.

Recommend moisture-meter verification along the warm segment and immediately off equipment curbs. Recommend a qualified roofer and/or plumber inspect this drainage path for proper function (open flow, debris, standing water, overflow onto the TPO). This is not a determination that the drainage has failed and is not a repair recommendation.
